The Road Inventory of San Joaquin River National Wildlife Refuge Los Banos, CA

Prepared By:
Federal Highway Administration
Central Federal Lands Highway Division
June 2012

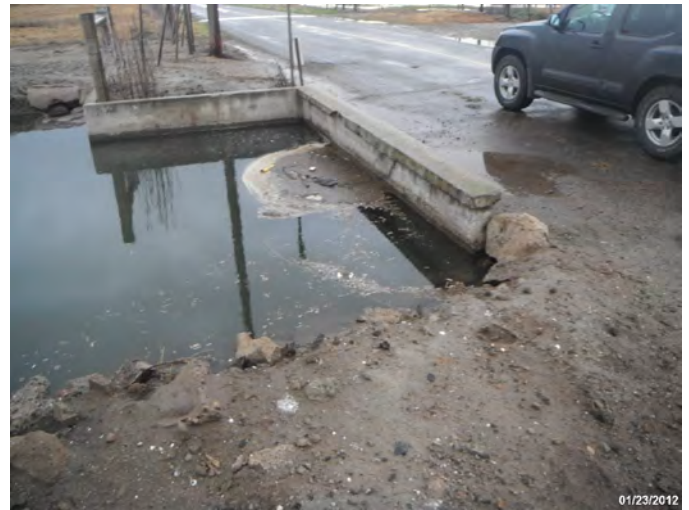
Photo: SAJO_C4_0352 Route: 100-001-0.0
Begin Section Property boundary is at midline and maintenance is done by neighbor and county

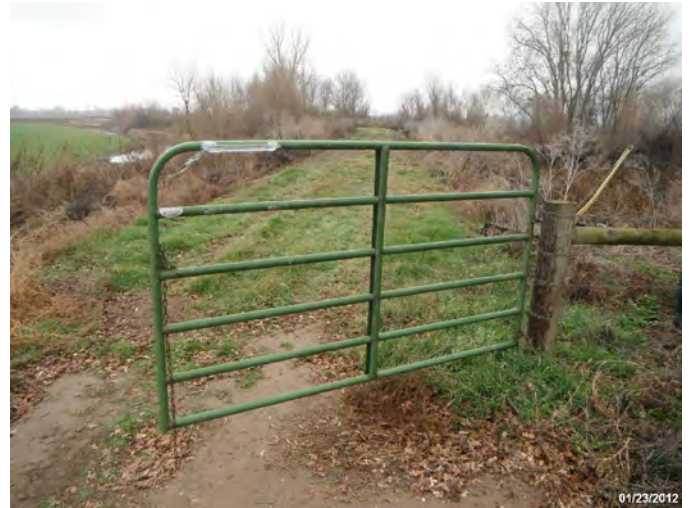
Photo: SAJO_C4_0409 Route: 406-003-1.95
Begin Section Not driven at refuge request due to soft mud

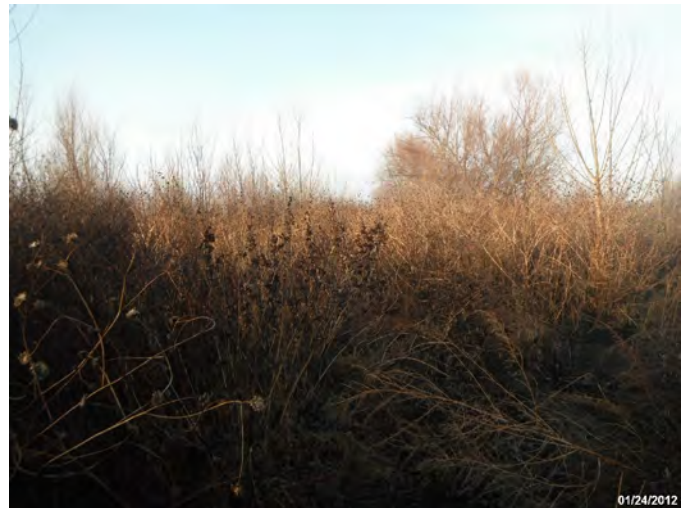
Photo: SAJO_C4_0003 Route: 415-001-0.39
Problem Area Road is too overgrown to travel

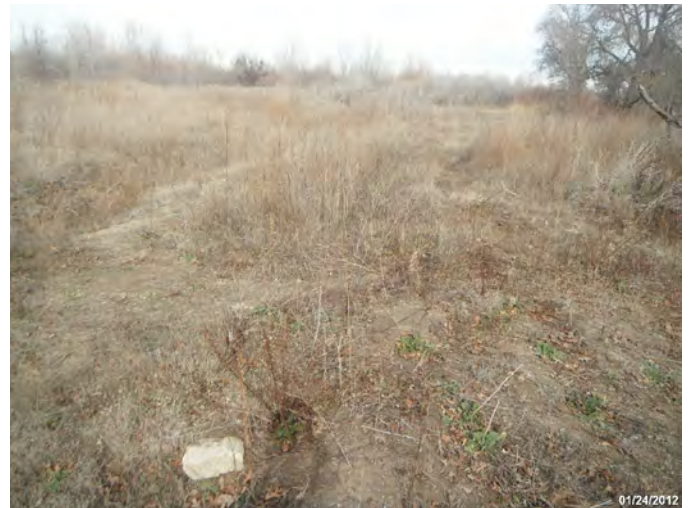
Photo: SAJO_C4_0070 Route: 430-001-0.09
Problem Area Road becomes too indistinct to drive
